Road Safety Audit Report

NH Route 43 at Raymond Road

NH Route 27 at Raymond Road

Candia, NH

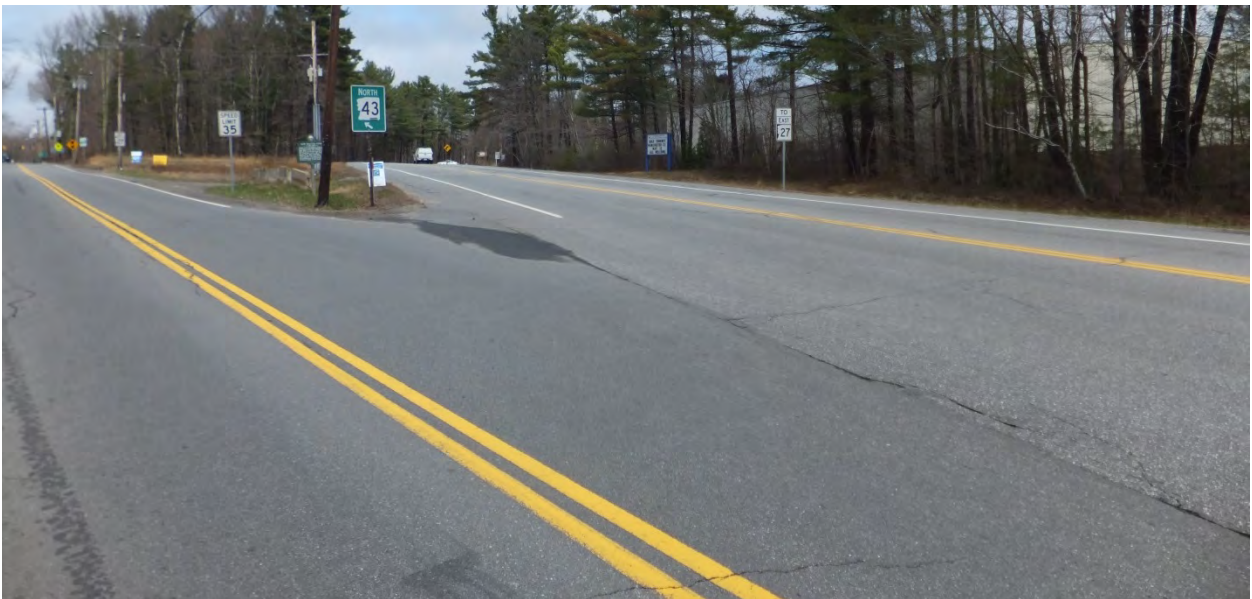
View from southbound Main Street approach looking north toward Raymond Road. The photo shows the severe skew of the intersection. Photo also shows the limited sight distance created by the crest curve.

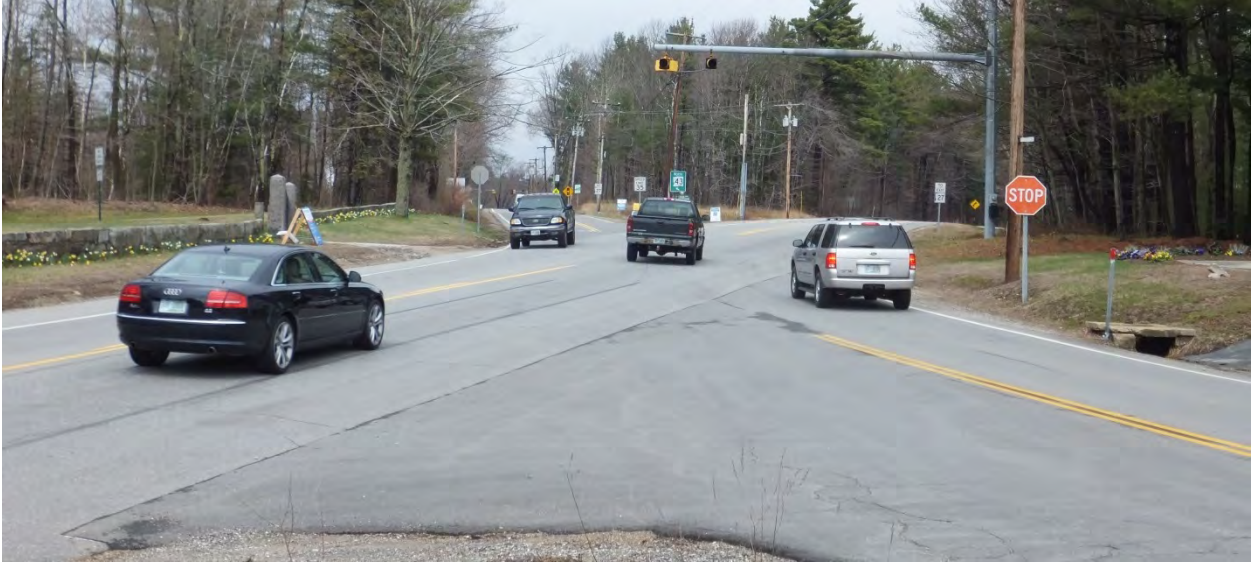
- **There are no turn lanes** for eastbound and westbound drivers on NH 43 and Raymond Road. As such, turning vehicles must wait in the through lane until there is an acceptable gap. This creates potential conflicts between the through movements and turning movements on the same approach. The queue waiting to turn left onto Main Street from eastbound NH 43 can also create a sight obstruction for drivers on southbound Main Street. Members of the RSA team noted that this is a particular concern during the evening peak. Additionally, the skew of the approaches results in a gap in the mainline double yellow centerline that is over 100 feet long. This adds to the confusion of the appropriate location to stop/yield on left turns from the mainline.

View of the intersection looking north. Photo shows the limited sight distance from northbound Main Street created by the vegetation and crest curve. The photo also shows the lack of turn lanes and a driver waiting in the through lane to turn left onto Main Street.

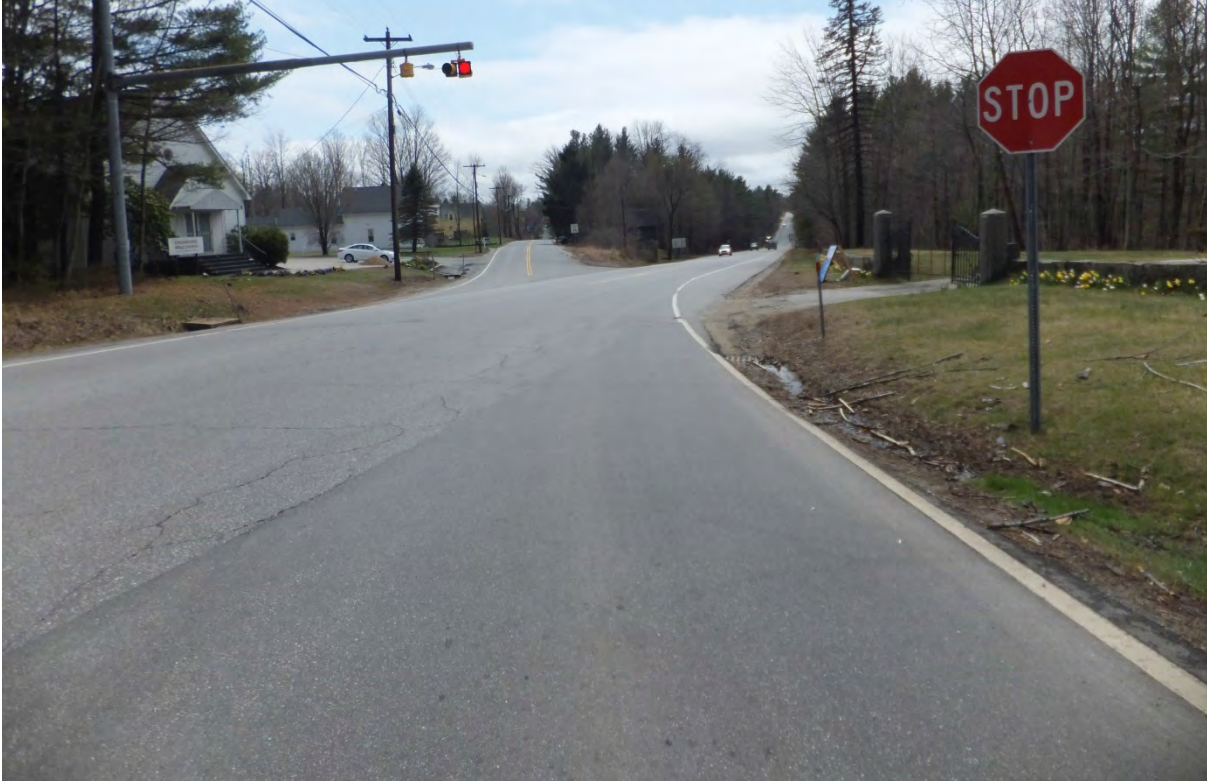
- **There is a wide break in the centerline** at the intersection. Pavement markings define the appropriate path for vehicles and help drivers to navigate, particularly at night. The wide break reduces guidance within the intersection, which can lead to potential safety issues. For example, the RSA team observed eastbound drivers traveling on NH 43 cutting the corner as they made a left turn and encroaching on the southbound lane of Main Street.

View of the intersection looking south from Main Street. Photo shows the extensive pavement within the intersection that is not defined by pavement markings.

- 3.1 Consider extending the centerlines and continuing the edgeline around the corner radius of NH 43 (eastbound) onto Main Street (southbound) and Raymond Road (westbound) onto Main Street (northbound).
- 3.2 Consider extending the no passing zone further west on NH 43.

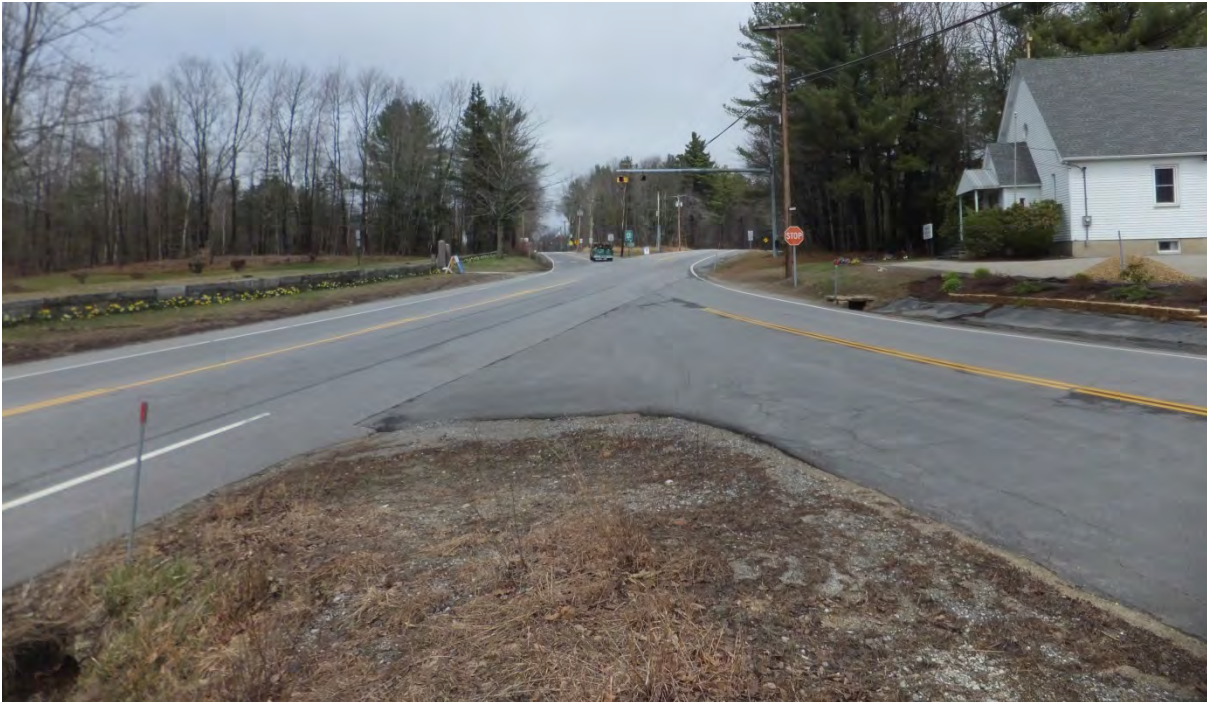
View of the intersection looking north from Main Street. Photo shows the discontinued edgeline from eastbound NH 43 onto southbound Main Street.

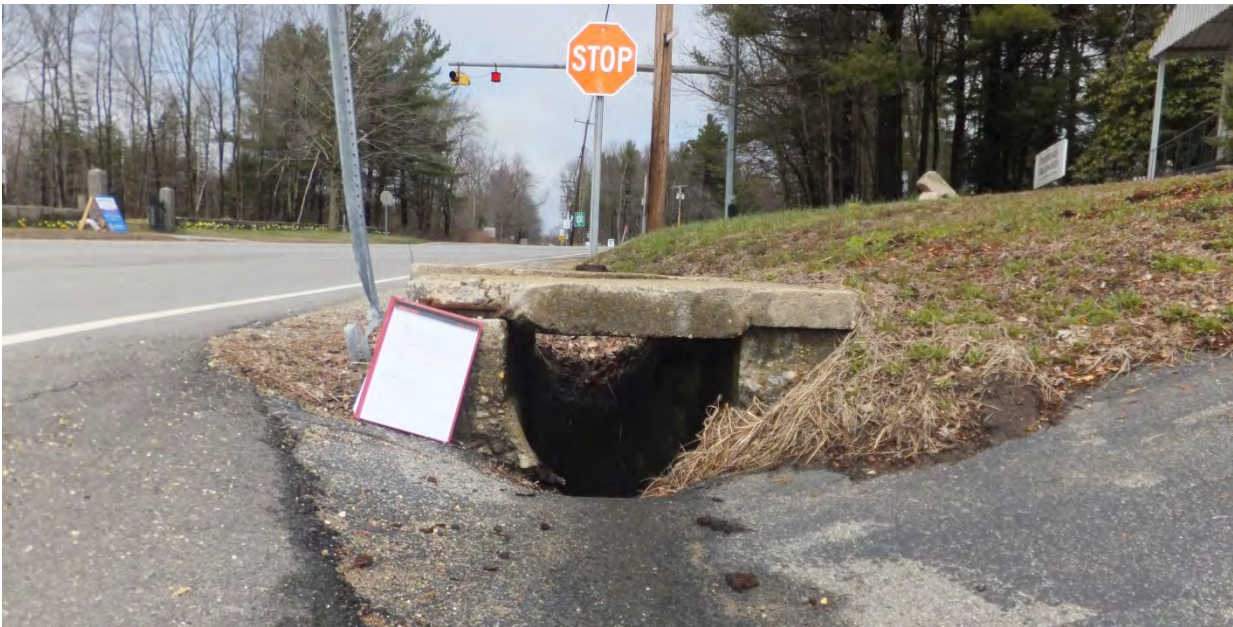
View of northbound approach on Main Street. Photo shows one of the two exposed drainage structures along the east side of the intersection.

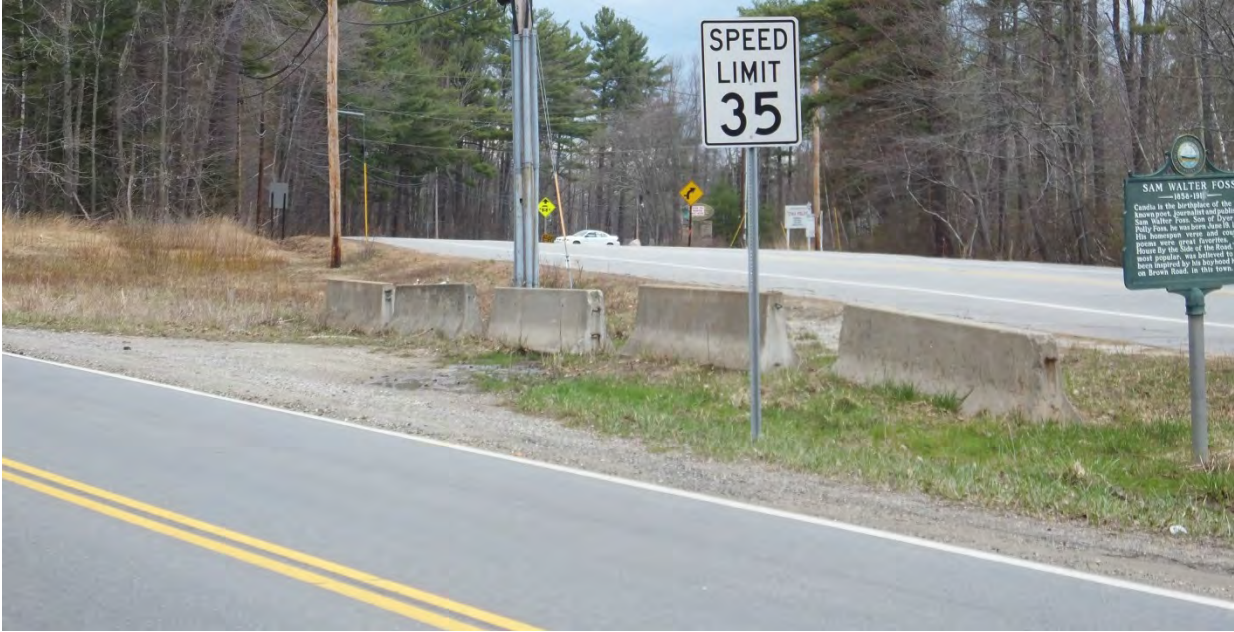
View of Main Street (left) and Raymond Road (right), looking north. Photo shows several roadside hazards including utility poles and concrete median barrier that is being used to discourage drivers from using the grass area as an unofficial intersection.

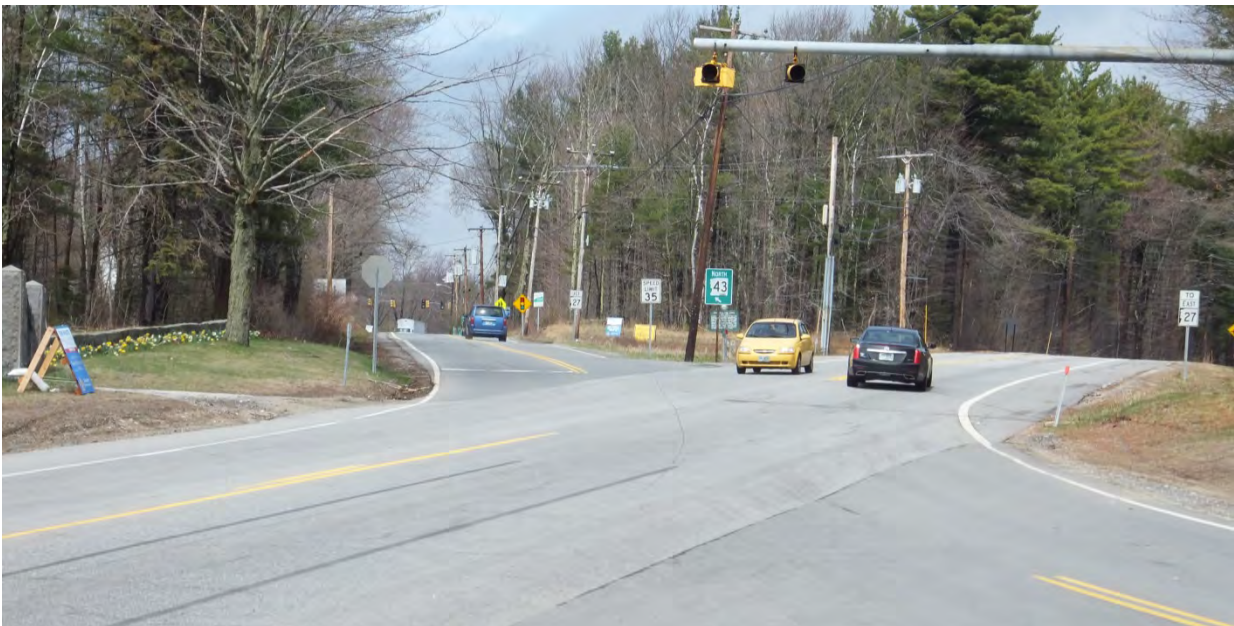
1. Access to the cemetery, which forms an informal fifth leg of the intersection.
2. Church driveway along the northbound approach of Main Street.
3. Access to the Candia Youth Athletic Association (CYAA), which is located approximately 500 feet east of the intersection along Raymond Road.
4. Access to the truck/storage property, which is located approximately 800 feet east of the intersection along Raymond Road.

View of the intersection looking north toward Main Street (top left) and Raymond Road (top right). Photo shows the proximity of the access to the cemetery (left).

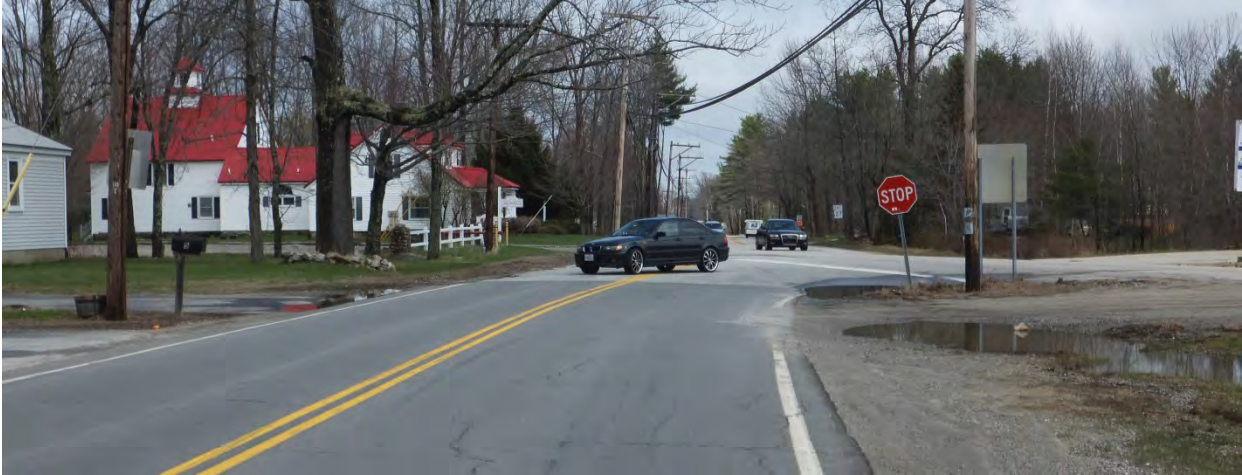
- Finally, the skew makes it difficult for drivers to turn left from Raymond Road onto High Street. The angle is so sharp that even smaller passenger cars track into the opposing lane of traffic on High Street. This issue is even more pronounced for larger vehicles, particularly trucks. The RSA team observed drivers using an unofficial dirt area to the west of the actual intersection to make turns.

View from eastbound High Street approach looking east toward NH 27 and Raymond Road. The photo shows the severe skew of the intersection. Photo also shows a passenger car tracking into the opposing lane as it turns left from Raymond Road.

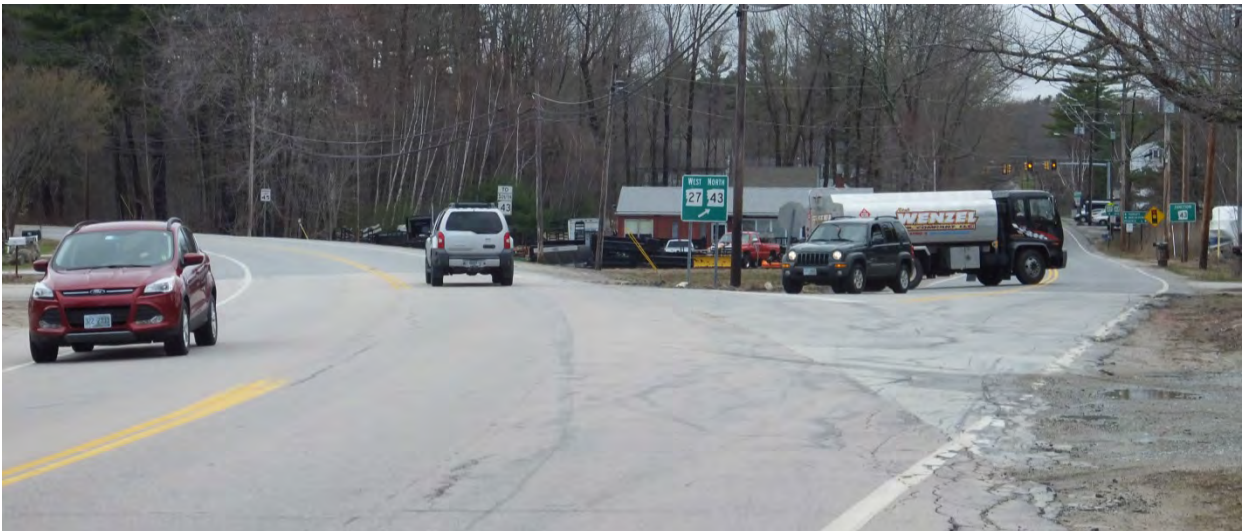
- **There is a horizontal curve on Raymond Road** to the southwest of this intersection. The curve, in combination with vegetation on the inside of the curve, limits sight distance to and from the intersection of NH 27 and Raymond Road. While the horizontal curve “limits” sight distance, the available stopping sight distance is approximately 400 feet and the available intersection sight distance is approximately 625 feet, which both exceed the AASHTO Green Book minimum sight distances for the posted speed (AASHTO, 2004). [Note that for a 45 MPH major road posted speed, the AASHTO Green Book indicates a 360 ft. stopping sight distance and 500 ft. intersection sight distance for left-turning vehicles from a stop.]

View of the High Street intersection looking west. Photo shows the skew of the intersection and limited sight distance to the southwest along Raymond Road due to the horizontal curve. The photo also shows a truck using an unofficial dirt path between High Street and Raymond Road to turn left from Raymond Road.

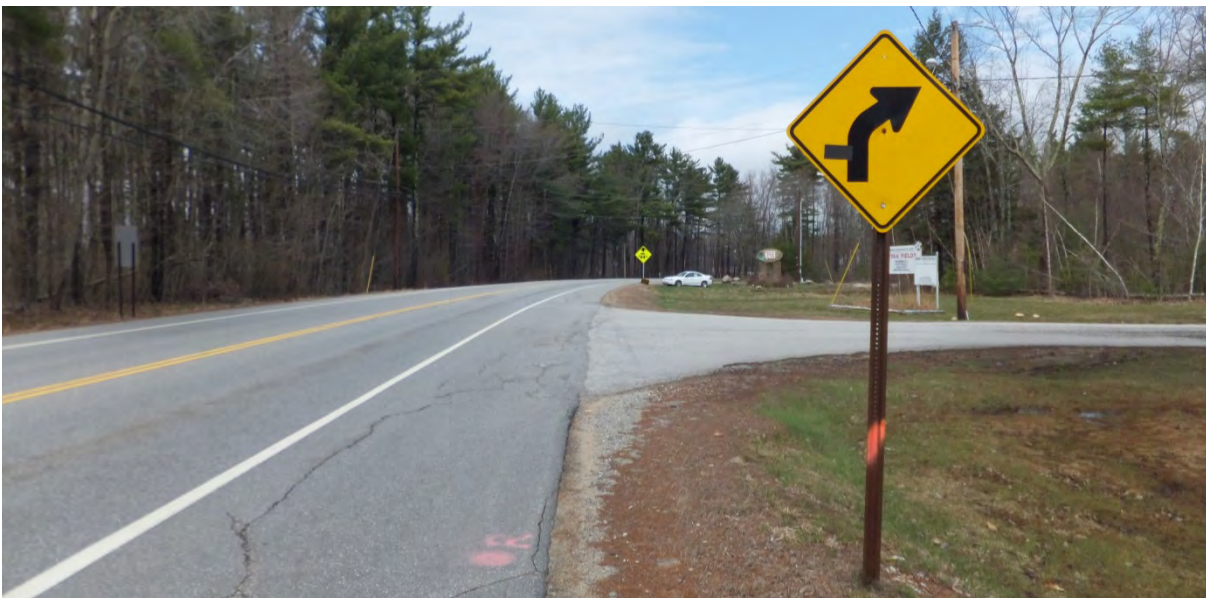
View of Raymond Road looking northeast toward High Street. Photo shows the existing intersection warning sign for High Street that is incorporated with the curve warning sign.

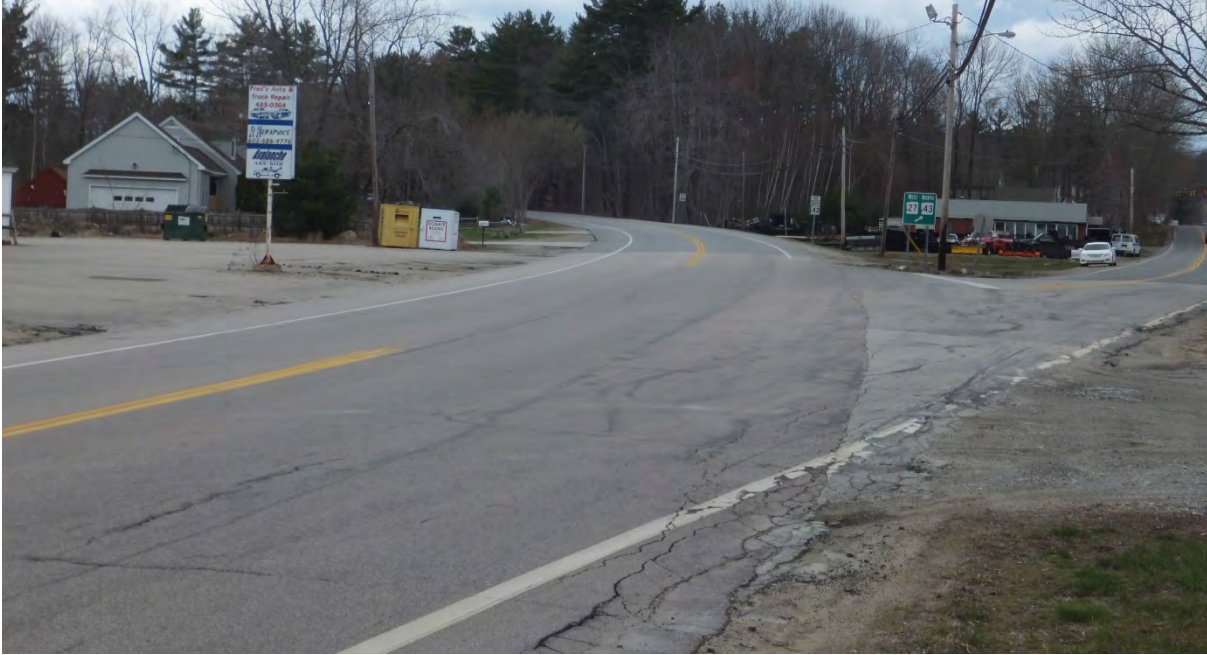
- **There is a wide break in the centerline and edgeline** at the intersection. Pavement markings define the appropriate path for vehicles and help drivers to navigate, particularly at night. The wide break reduces guidance within the intersection, which can lead to potential safety issues. The edgeline along the north side of NH 27 continues from NH 27 onto High Street, which gives the appearance that the through movement is from westbound NH 27 onto High Street.

View of the intersection looking southwest toward Raymond Road (left) and High Street (right). Photo shows the wide expanse of pavement without markings within the intersection. Photo also shows the edgeline continuing from westbound NH 27 onto High Street.

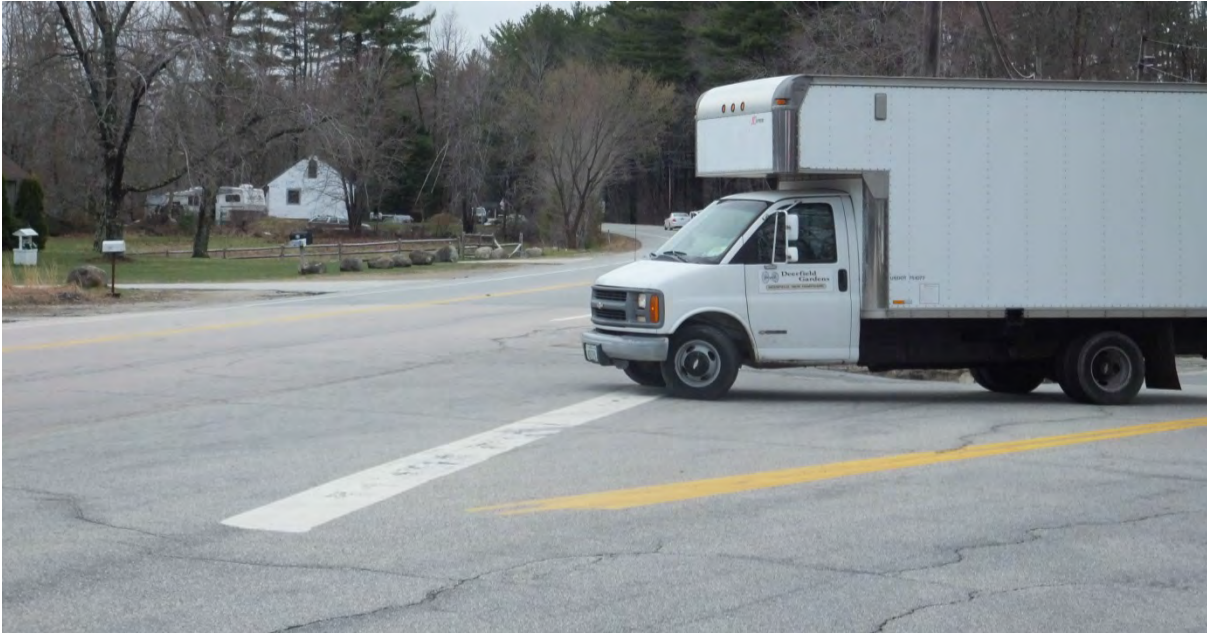
- **The intersection approach on High Street is not well defined** by the current layout of the stop bar and centerline on High Street. Specifically, there is a long stop bar and the centerline follows the skewed alignment of the intersection. Some drivers are positioning their vehicle more perpendicular to the mainline (as shown in the photo below), but others are not.

View of the intersection looking southwest from High Street. Photo shows the extended length of the stop bar and alignment of the centerline.

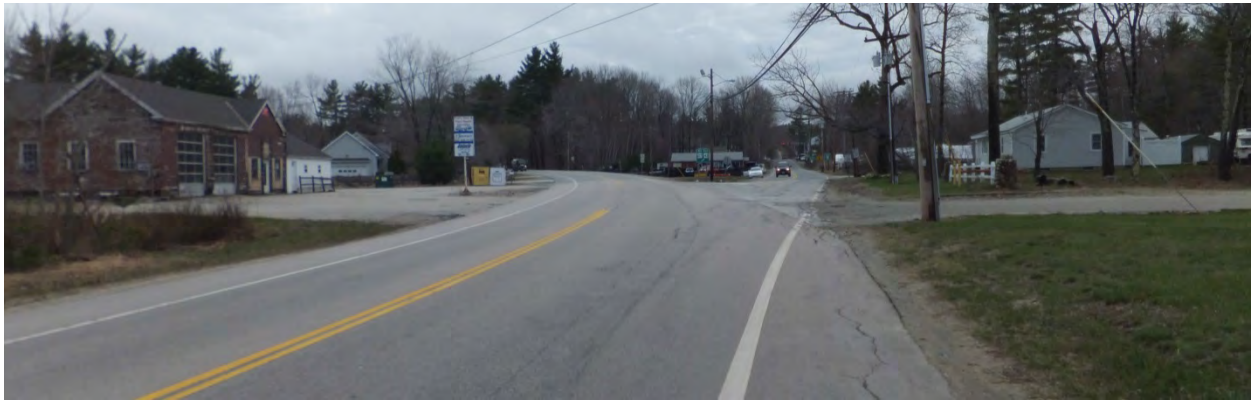
1. Access to the garage along Raymond Road.
2. Access to the boat storage, propane, and oil companies along High Street.
3. Access to local houses.

View of NH 27 looking west toward High Street. Photo shows two access points, one on either side of the road, that are located within the intersection.

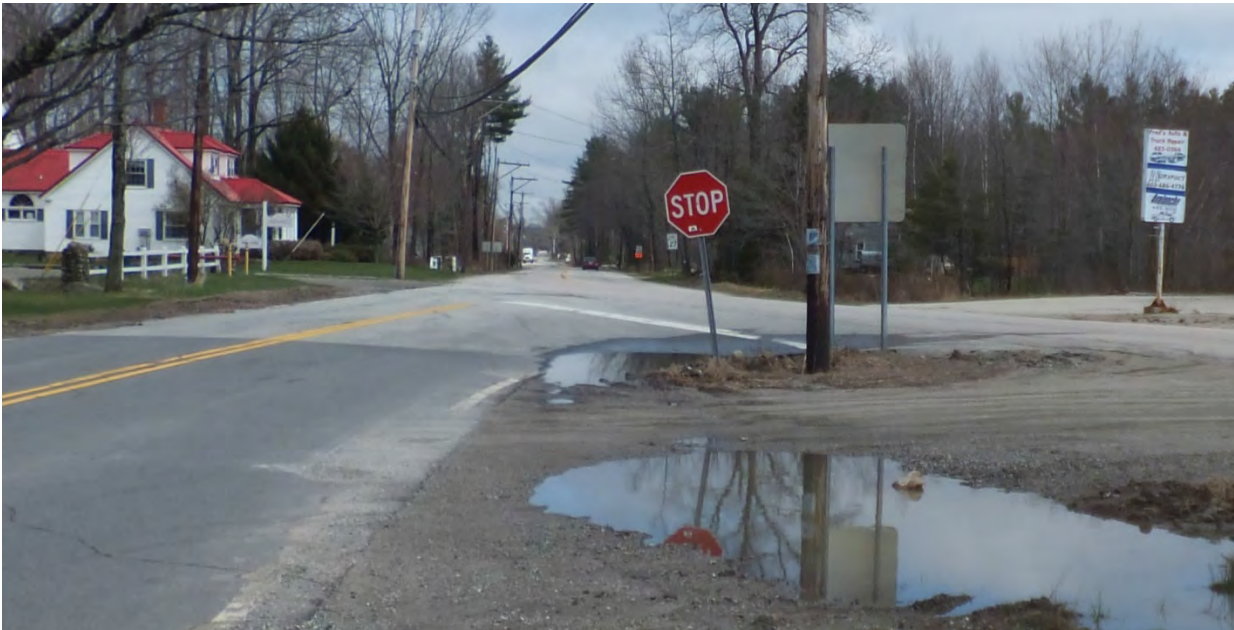
- **There is standing water in the sight triangle** between High Street and Raymond Road. The RSA was conducted soon after a rain event and the water was flooding onto the roadway at the High Street approach.

While there were no recent weather-related crashes at the intersection, standing water on the roadway is a safety issue because it reduces friction, increasing stopping distance, and can cause hydroplaning although this is not likely at low speeds where the current water is ponding.

View of High Street looking east toward NH 27. Photo shows standing water on and along the intersection approach several hours after a rain event.
