October 19, 2022

Re: Risk Management Assessment Candia Police Department

Town of Candia Police Department Risk Management Assessment and Recommendations

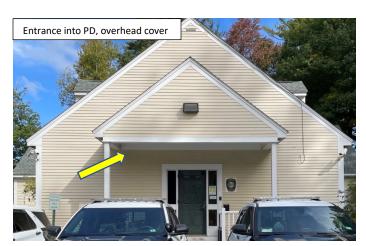
The main entrance into the Police Department is from a parking lot located on the south side of the building. Entry is from a single door which leads to a small lobby area. This entryway has overhead cover to protect from outside elements. Once inside the waiting area, there is a door to enter the PD. That door is locked and only opened by authorized personnel.

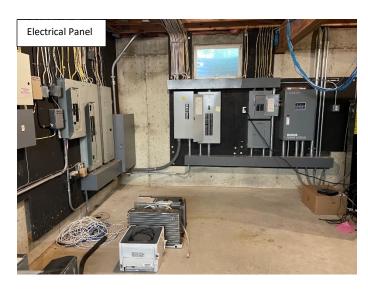
When passing through the basement door, it leads to the location of the electrical panel and data storage rack which supplies utilities for the entire building.
